Triaxial Compression Test Results

Project:	Tharisa Minerals	Date Received:	2013/08/02
Job Number:	2013-B-1782	Laboratory Number:	1782-1
Field Sample Number:	TP 1	Depth (m):	1.7

REPORT ON A GEOTECHNICAL INVESTIGATION FOR THE THARISA TAILINGS STORAGE FACILITY IN RUSTENBURG

EPOCH RESOURCES (PTY) LTD.
THARISA MINERALS TAILINGS STORAGE FACILITIES
SITE PLAN SHOWING POSITIONS OF TEST PITS

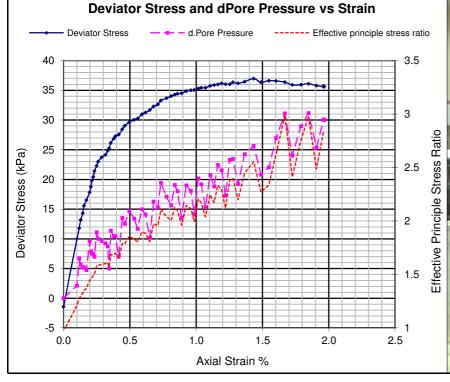
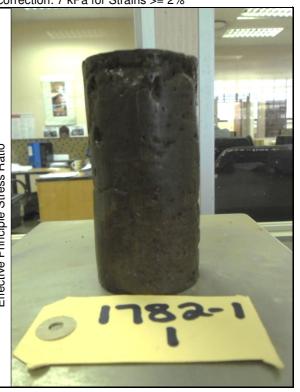
SATURATION DATA Test No. 1

Remarks: A Consolidated Undrained test on an undisturbed sample tested saturated.

Rate of strain (%/hour):	0.22					
Initial pore pressure (kPa):	344.6	Initial effective stress (kPa):	49.4			
Parameters at failure:						
Failure Criterion:	Max. Deviator Stre	ess				
Axial strain (%):	1.43					
Deviator stress (kPa):	37.0		Principle Stresses (kPa)			
Excess pore pressure (kPa): 25.6 σ_1 σ_3				G 3'		
Effective principle stress rat	tio: 2.554		86.4	60.8	49.4	23.8

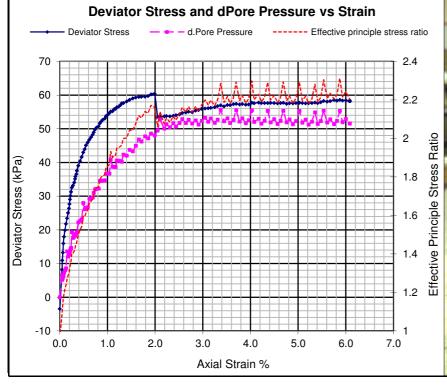
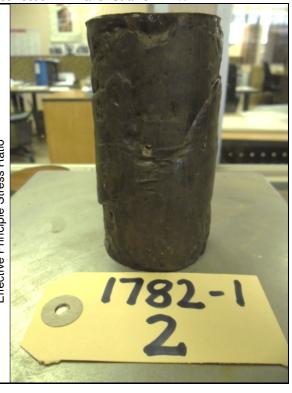
SATURATION DATA Test No. 2

Remarks: A Consolidated Undrained test on an undisturbed sample tested saturated.

Rate of strain (%/hour):	0.24					
Initial pore pressure (kPa):	336.0	Initial effective stress (kPa):	100.0			
Parameters at failure:						-
Failure Criterion:	Max. Deviator Str	ess				
Axial strain (%):	1.99					
Deviator stress (kPa):	60.4		Principle Stresses (kPa))
Excess pore pressure (kPa): 48.0			σ1	σ1'	O 3	O 3'
Effective principle stress rati	io: 2.162		160.4	112.3	100.0	52.0

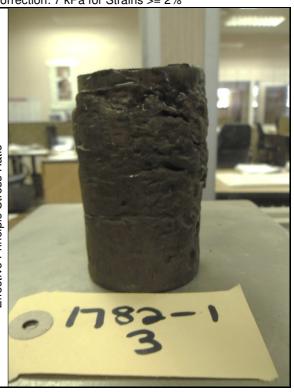
Rate of strain (%/hour):	0.12						
Initial pore pressure (kPa):	341.9	Initial effective stre	ess (kPa): 200	.1			
Parameters at failure:							
Failure Criterion:	Max. Effective Prir	nciple Stress Ratio					
Axial strain (%):	7.72						
Deviator stress (kPa):	108.9			Principle Stresses (kPa)			
Excess pore pressure (kPa): 105.5 σ_1 σ_3				G 3'			
Effective principle stress rate	tio: 2.152		3	309.0	203.5	200.1	94.6

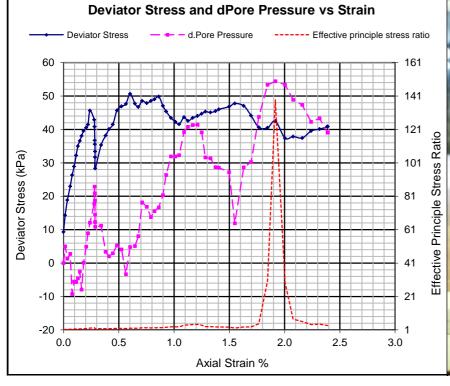
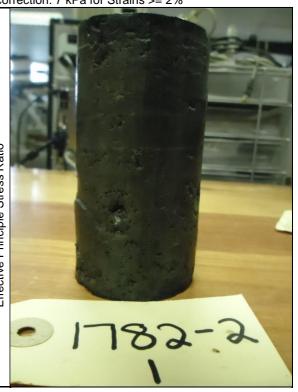
Remarks:	A Consolidated Undrained test on an undisturbed sample tested saturated. The data from this test was not included in
	the determining the shear strength parameters (c' and phi). PWP pressure sensor suspected of being too unstable
	prior to being replaced. Insufficient time & sample to repeat specimen.

Rate of strain (%/hour):	0.045					
Initial pore pressure (kPa):	295.3	Initial effective stress (kPa):	54.7			
Parameters at failure:						
Failure Criterion:	Max. Deviator Stre	ess				
Axial strain (%):	0.60					
Deviator stress (kPa):	50.7			Principle Str	esses (kPa)	
Excess pore pressure (kPa)): 4.8		σ1	σ1'	σ3	σ3'
Effective principle stress rat	io: 2.015		105.4	100.6	54.7	49.9

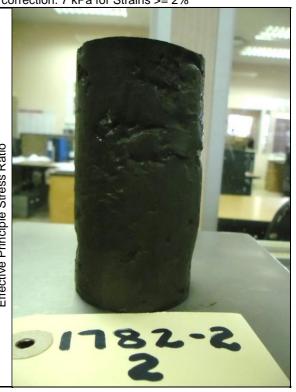
Rate of strain (%/hour):	0.080					
Initial pore pressure (kPa):	347.4 I	nitial effective stress (kPa):	96.6			
Parameters at failure:						
Failure Criterion: M	lax. Deviator Stres	SS				
Axial strain (%):	1.77					
Deviator stress (kPa): 86.1 Principle Stresses (kPa))	
Excess pore pressure (kPa):	: 43.5		σ1	σ1'	σ3	σ3'
Effective principle stress ratio	o: 2.622		182.7	139.2	96.6	53.1

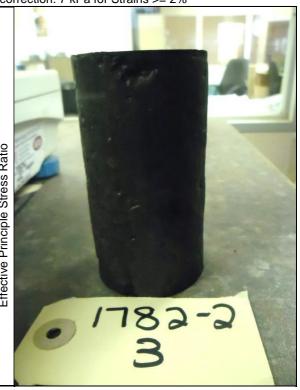
Rate of strain (%/hour):	0.805					
Initial pore pressure (kPa):	341.5	Initial effective stress (kPa):	199.5			
Parameters at failure:						
Failure Criterion:	Max. Effective Prir	nciple Stress Ratio				
Axial strain (%):	4.27					
Deviator stress (kPa):	121.3			Principle Str	resses (kPa)	
Excess pore pressure (kPa)): 117.9		σ1	σ1'	σ3	σ3'
Effective principle stress rat	tio: 2.487		320.8	202.9	199.5	81.6

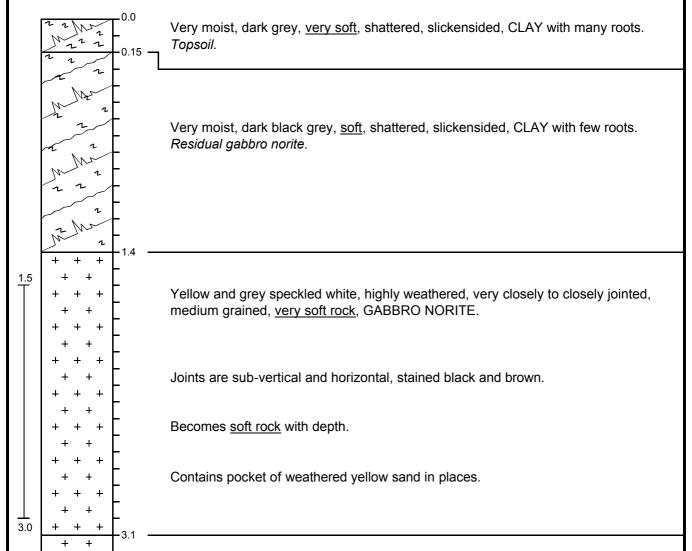
PROFILE SHEET TP1 Epoch Resources (Pty) Ltd. Tharisa Minerals Tailings Storage Facilities Y -050602

- 1. Bottom of hole at 3,1 m. Partial refusal on soft rock GABBRO NORITE.
- 2. No ground water seepage encountered.
- 3. Bulk sample taken from 1,5 to 3,0 m.
- 4. Co-ordinates determined from Garmin hand-held GPS to WGS 84 system.

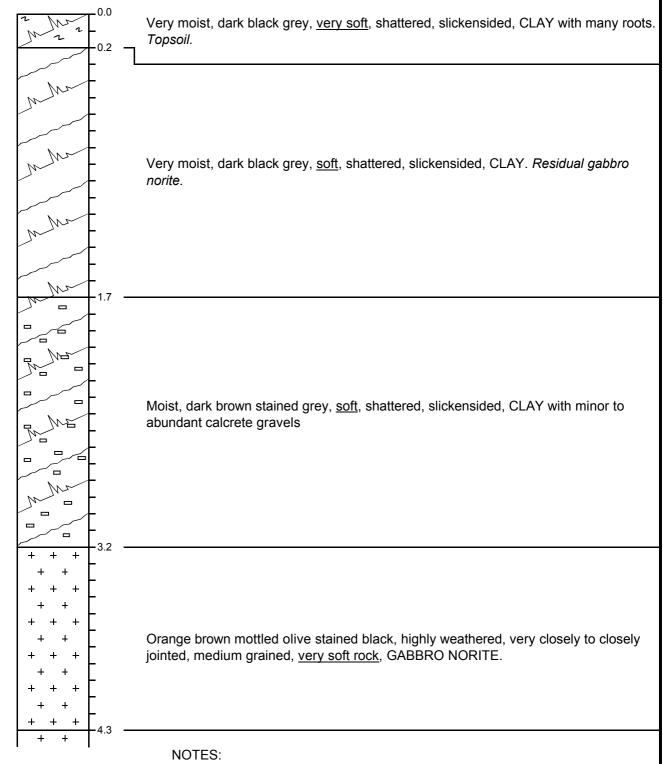
PROFILE SHEET TP3 Epoch Resources (Pty) Ltd. Tharisa Minerals Tailings Storage Facilities Y -050759

- 1. Bottom of hole at 4,3 m. Partial refusal on soft rock GABBRO NORITE.
- 2. No ground water seepage encountered.
- 3. Co-ordinates determined from Garmin hand-held GPS to WGS 84 system.

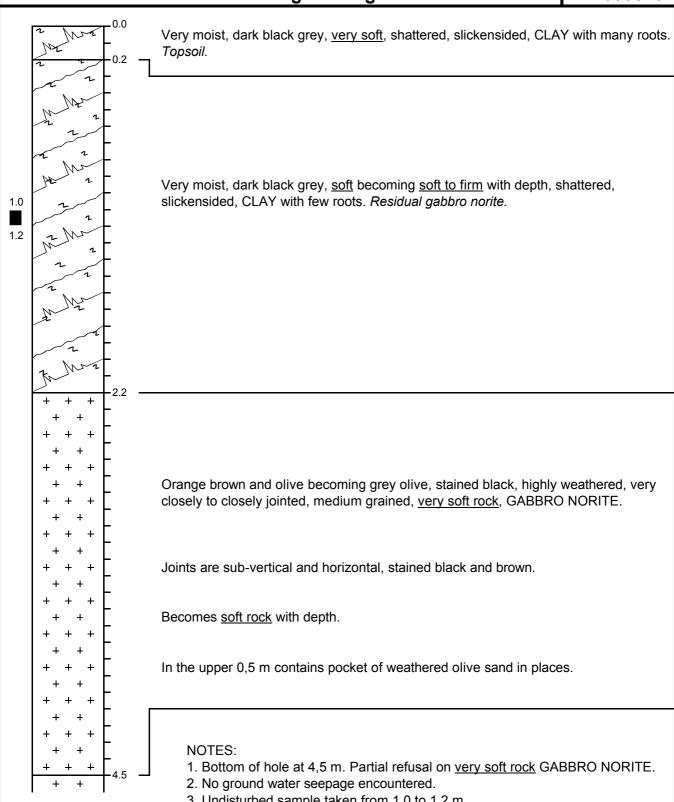
PROFILE SHEET TP4 **Epoch Resources (Pty) Ltd.** X 2848264 **Tharisa Minerals Tailings Storage Facilities** -050828

- 3. Undisturbed sample taken from 1,0 to 1,2 m.
- 4. Co-ordinates determined from Garmin hand-held GPS to WGS 84 system.

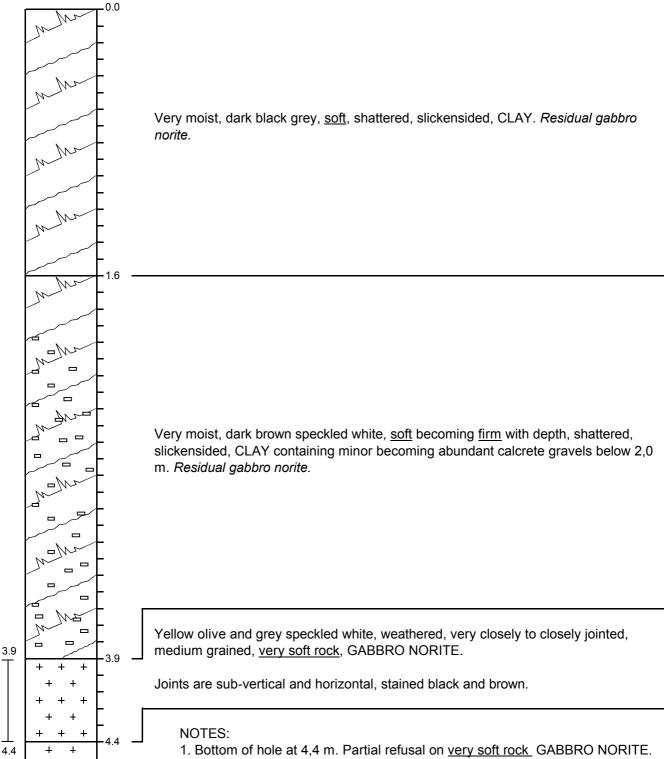
PROFILE SHEET	TP13
Epoch Resources (Pty) Ltd.	X 2848138
Tharisa Minerals Tailings Storage Facilities	Y -052506

- 2. No ground water seepage encountered.
- 3. Bulk sample taken from 3,9 to 4,4 m.
- 4. Co-ordinates determined from Garmin hand-held GPS to WGS 84 system.

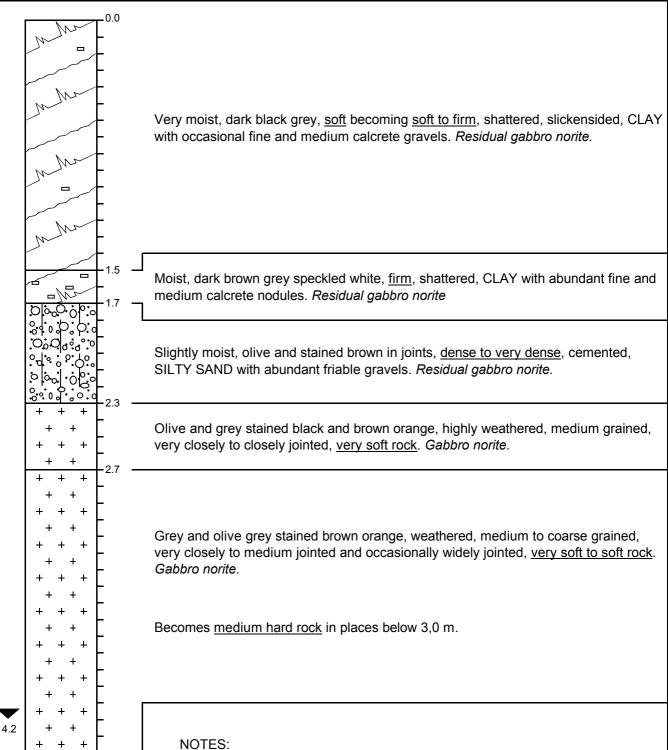
PROFILE SHEET	TP21
Epoch Resources (Pty) Ltd.	X 2848169
Tharisa Minerals Tailings Storage Facilities	Y -050737

- 1. Bottom of hole at 4,6 m. Refusal on soft to medium hard rock gabbro norite.
- 2. Ground water seepage encountered below 4,2 m. Water standing at 4,2 m after 24 hours.
- 3. Co-ordinates determined from Garmin hand-held GPS to WGS 84 system.

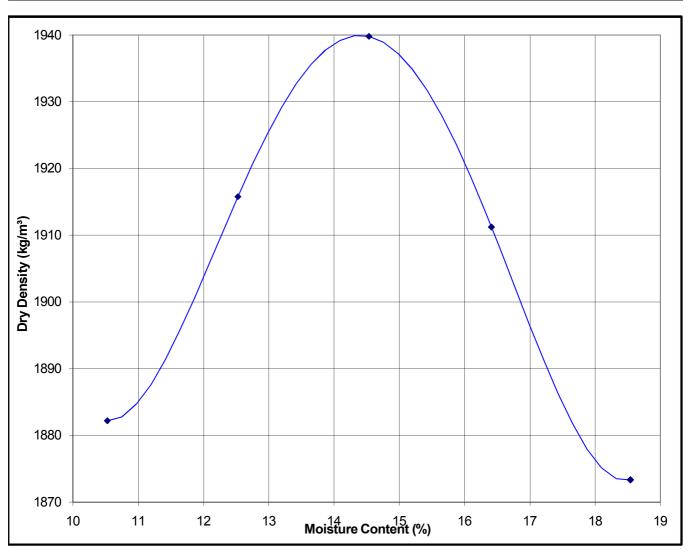
Maximum Dry Density: 1940 kg/m³ Optimum Moisture Content: 14.3 %

Analysis according to Method A7 of TMH1 of 1986.

Samples of the sand and rock fragments tested are all fairly uniform with optimum moisture contents of 12,4% to 14,3% for the sand and 8,2% for the rock fragments respectively, which is typical of a relatively finer grained sand and much coarser rock fragments sampled. The maximum Proctor dry densities for the sand are between 1940 kg/m³ and 2271 kg/m³ and for the rock fragments is 2197 kg/m³.

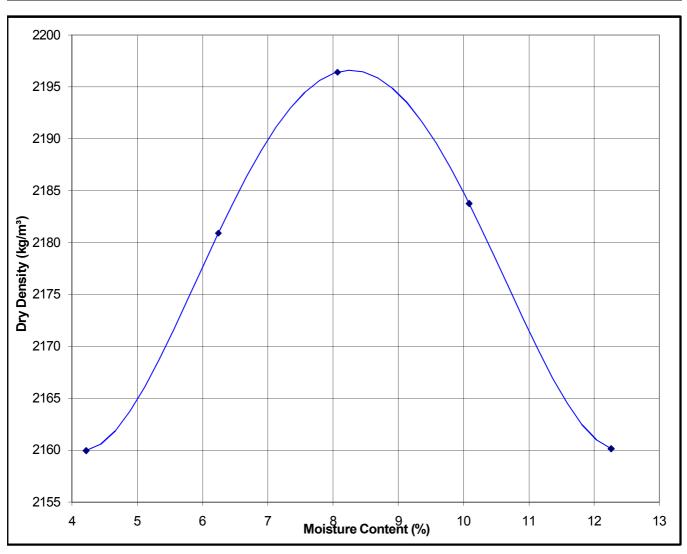
Maximum Dry Density: 2197 kg/m³ Optimum Moisture Content: 8.2 %

Analysis according to Method A7 of TMH1 of 1986.

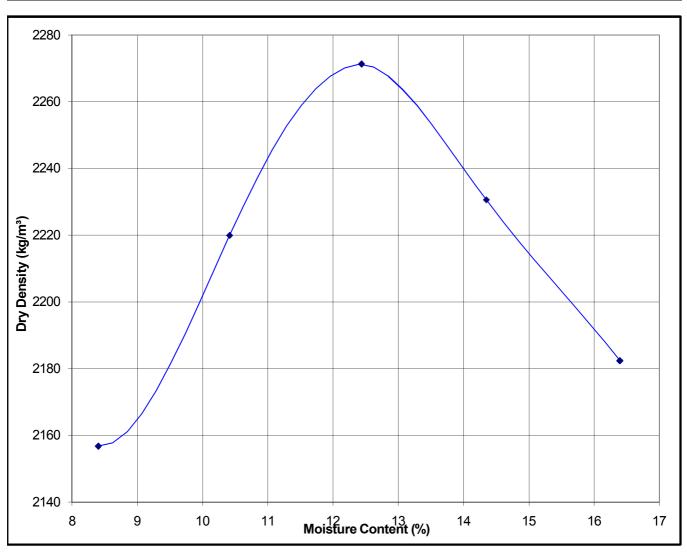
Maximum Dry Density: 2271 kg/m³ Optimum Moisture Content: 12.4 %

Analysis according to Method A7 of TMH1 of 1986.

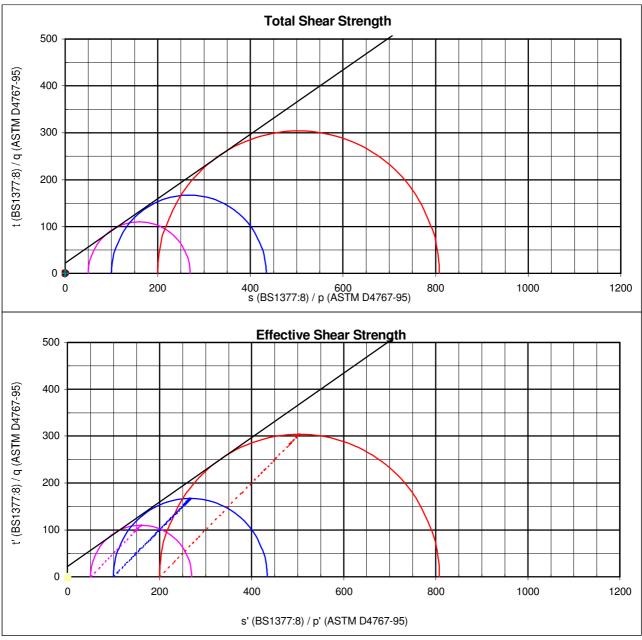
COHESION (kPa)	FRICTION ANGLE
TOTAL STRESSES	22	35
EFFECTIVE STRESSES	22	35

A Consolidated Drained test on a remoulded sample tested saturated.

Hole No.	Depth (m)	Soil Description	Remoulded/ Undisturbed	Type of Test	Dry density (kg/m³)	Moisture content (%)	Cohesion (kPa) c'	Angle of friction (degrees) φ'
TP2	1.6 – 4.0	Residual gabbro norite - Sand	Remoulded	CD	1820	14.6	22	35
TP4	1.0 – 1.2	Residual gabbro norite - Clay	Undisturbed	CU	1259	33.7	20	12
TP6	4.7 – 5.1	Very soft rock gabbro norite	Remoulded	CD	2051	9.5	15	38
TP10	4.0 – 4.2	Residual gabbro norite - Clay	Undisturbed	CU	1299	38.4	30	11
TP19	1.2 – 3.4	Residual gabbro norite - Sand	Remoulded	CU	1994	14.0	3	43

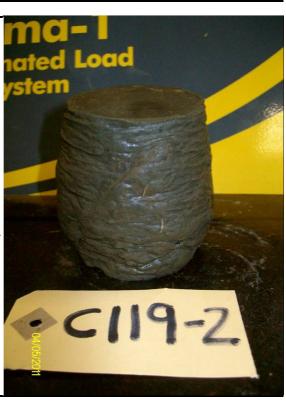
Rate of strain (%/hour):	9					
Initial pore pressure (kPa):	350.3 Initi	al effective stress (kPa):	96.7			
Parameters at failure:						
Failure Criterion: Ma	ax. Effective Principl	le Stress Ratio				
Axial strain (%):	9.97					
Deviator stress (kPa):	82.6			Principle Str	resses (kPa))
Excess pore pressure (kPa):	49.5		σ 1	σ1'	O 3	O 3'
Effective principle stress ratio	2.750		179.3	129.8	96.7	47.2

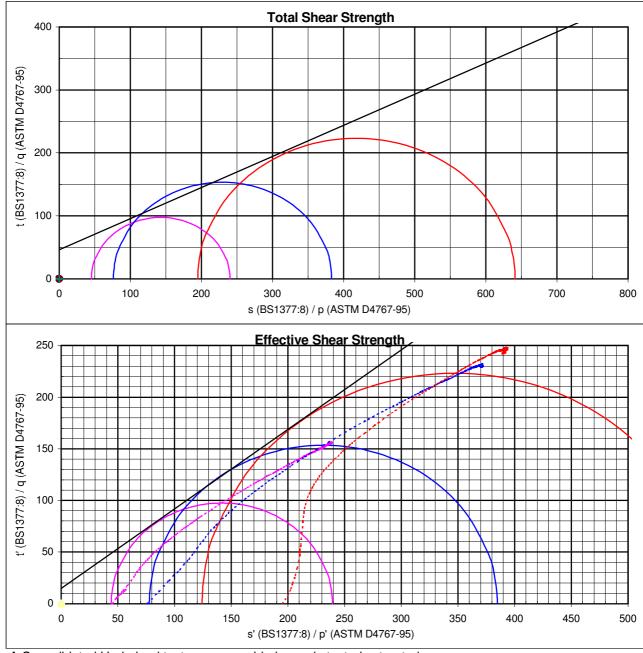
COHESION (kPa)	FRICTION ANGLE
TOTAL STRESSES	46	26
EFFECTIVE STRESSES	15	38

A Consolidated Undrained test on a remoulded sample tested saturated.

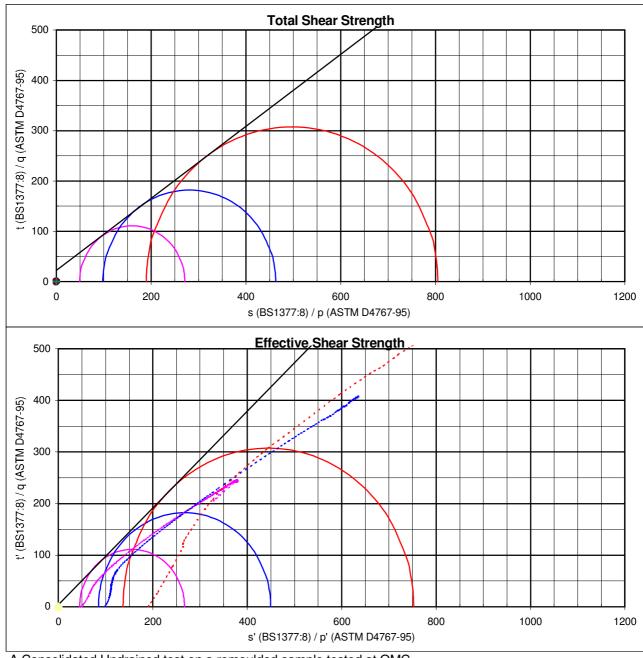
COHESION (kPa)	FRICTION ANGLE
TOTAL STRESSES	22	36
EFFECTIVE STRESSES	3	43

A Consolidated Undrained test on a remoulded sample tested at OMC.
