Geotechnical And Geophysical Survey Description for MPR Siting at Necsa Pelindaba

***Client: Manyabe Consultancy and Necsa
GCS Report Reference: 23-0071R02
Client Reference: MPR-EXT-DES-00001***

Reference: 23-0071R02

This report is a desk-top review, from published and unpublished data by the authors, of the regional setting and local geological and geotechnical conditions for 2 small sites that may be selected for an isotope producing, small multipurpose nuclear reactor at Necsa's Pelindaba site.

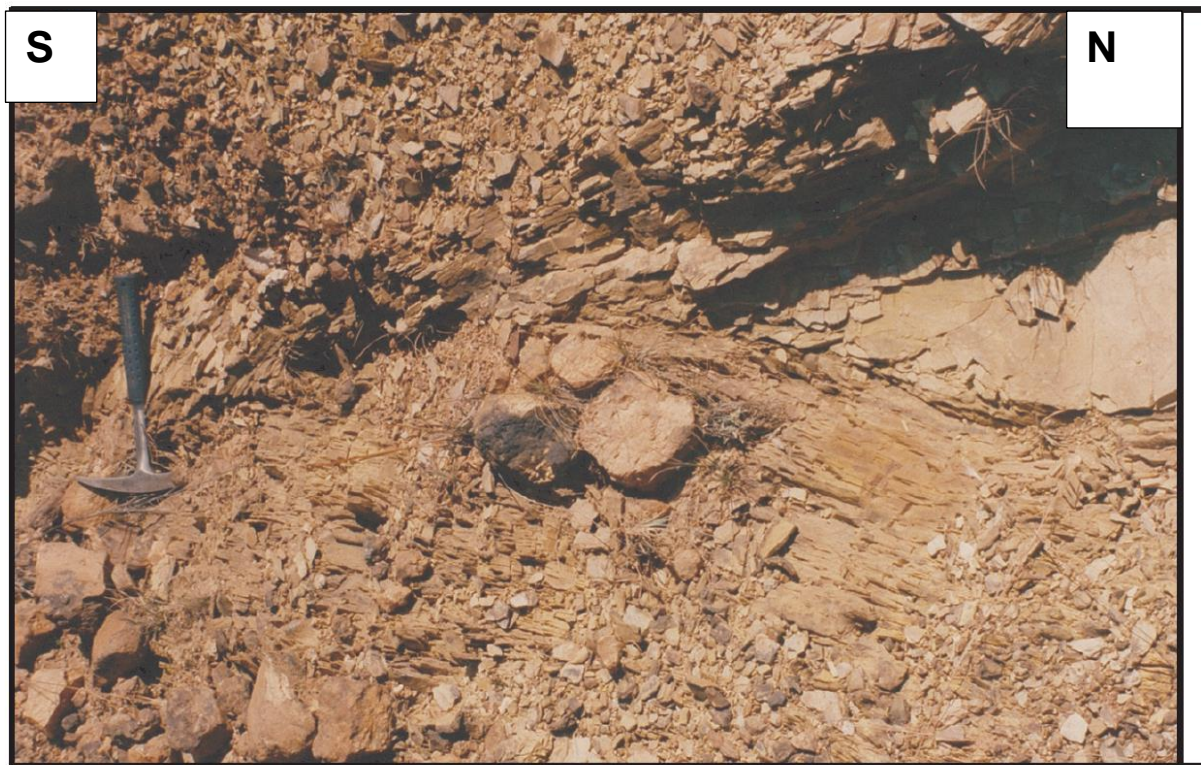
Fig. A3: Tight, probably faulted and overturned fold in slate (view to west), lower Timeball Hill Formation near Glen Africa Country Lodge (cf. Figure 2); bedding dips: upper limb 57° to SE, lower limb 22° to ENE (Ingram et al., 2000).
