# Old Tailings Storage Facilities (South Shaft and Twin Shaft TSFs) Design Basis Report

**South Deep Gold Mine**

**Gold Fields Limited**

SLR Project No.: 723.000038.00001

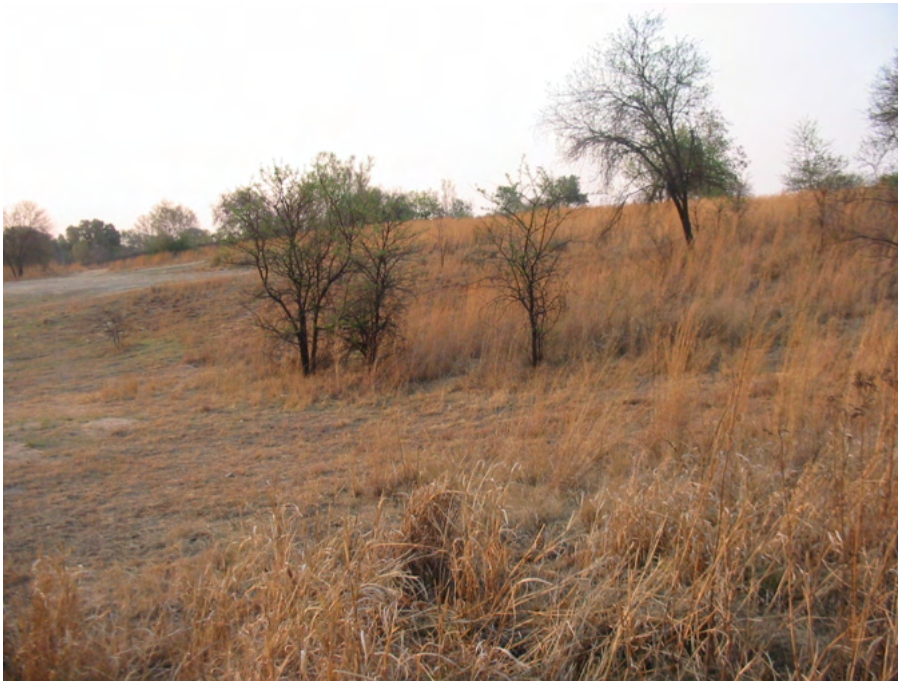
**FIGURE 15-1: FUTURE APPEARANCE OF THE OUTER SLOPE AT CLOSURE**

GAA put together a closure framework in order to allow the proposed tailings dam to comply with closure requirements and be in visual 'harmony' with the surrounding landscape (Refer to GAA Report No. 10307/10462/15/W). Figure 15-1 gives an indication as to the target visual appearance of the slope. The following concurrent rehabilitation activities have been provided for in terms of the budget and are assumed to be carried during the operational life of the facility:

- Although the dam is designed without step-ins on the side slopes, for practical reasons, access ramps will have to be constructed on the slopes. When some of the ramps become redundant at closure, they will be dozed and rehabilitated to blend in with the surrounding vegetated slope.

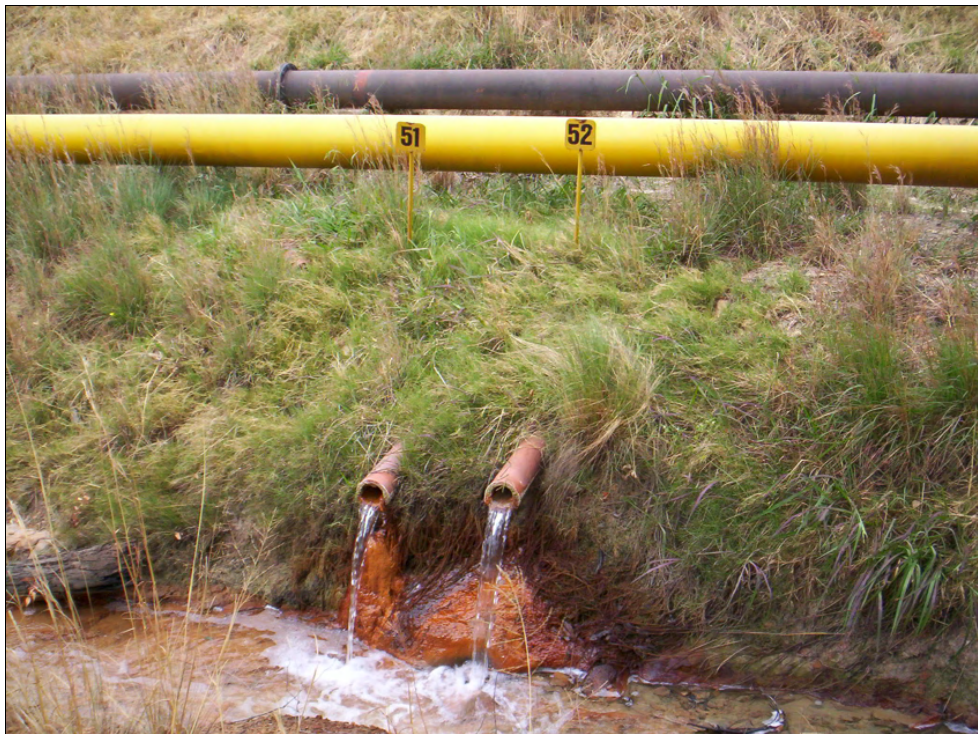
**FIGURE 3: UNDERDRAIN 51 AND 52 AT THE NEW TSF**

The water collected from the underdrains of the operational TSF was colourless as shown in Figure 3. The sample contained some orange particulates and had a slight odour. The sample collected from the underdrain to old TSF was orange/brown in colour as shown in Figure 4. There was a strong ammonia odour coming from the water and there was scum on the surface of the stream at the point of discharge. The pH and electrical conductivity (EC) of the water samples was recorded at the time of sampling. The sample locations are shown in Appendix 1.

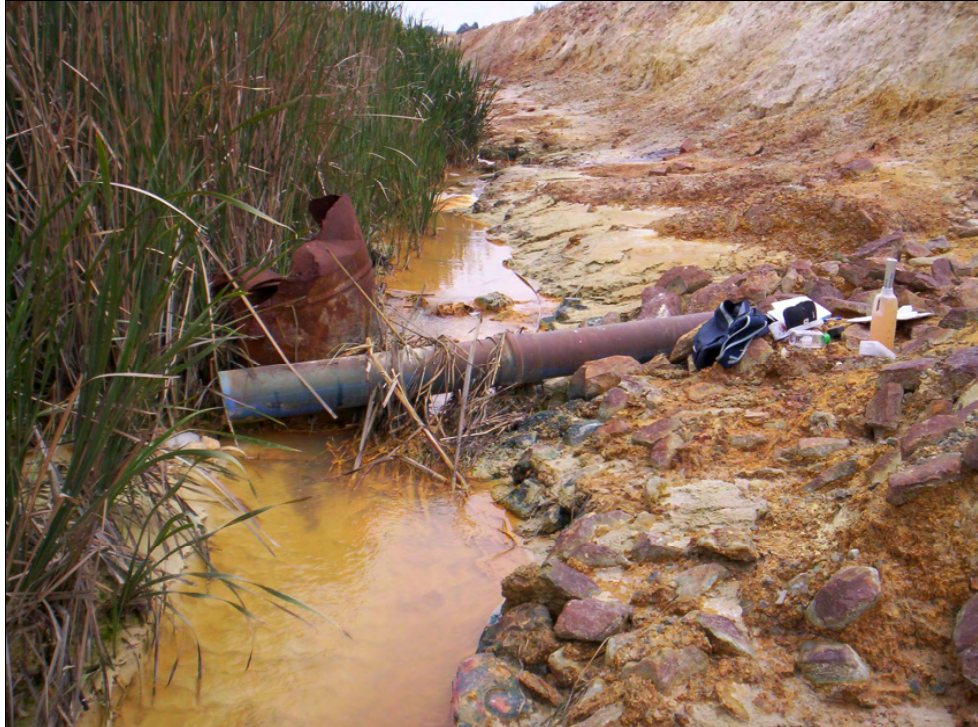
**FIGURE 4: UNDESIGNATED UNDERDRAIN AT THE OLD TSF**

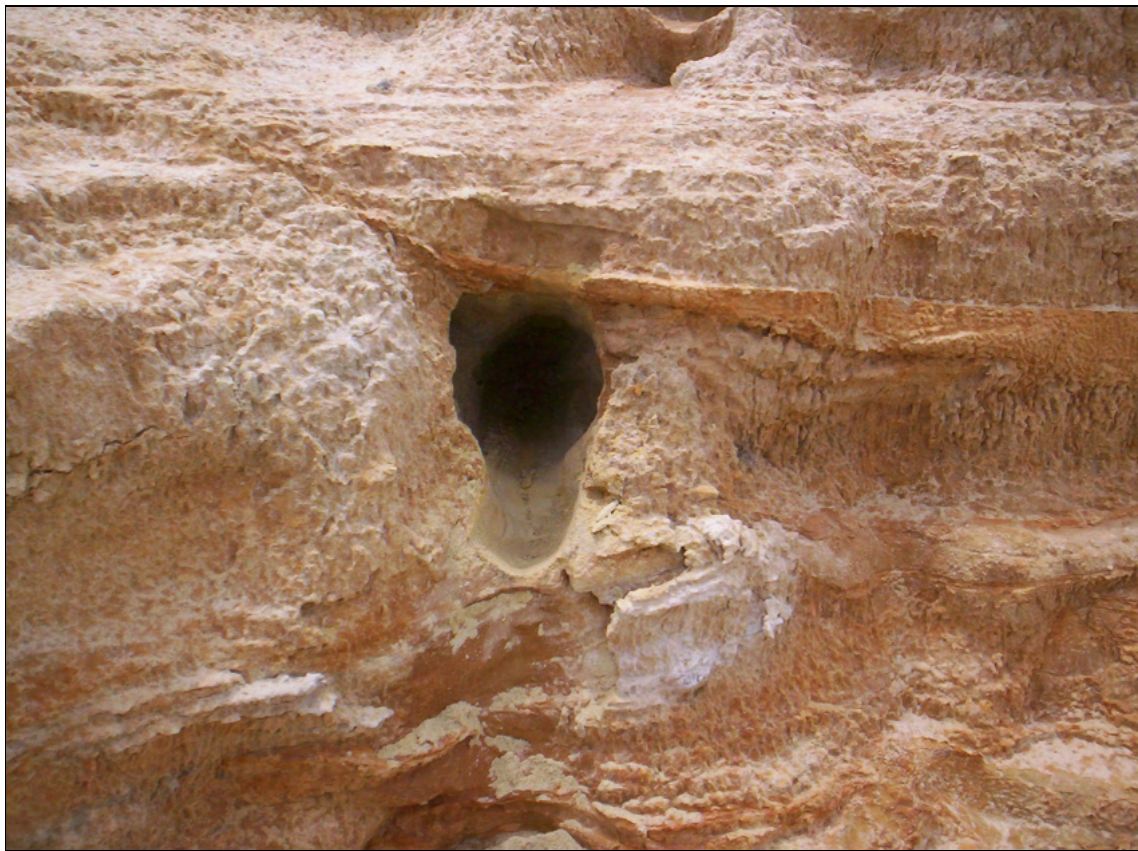
Location of Collected Sample from Side Slope

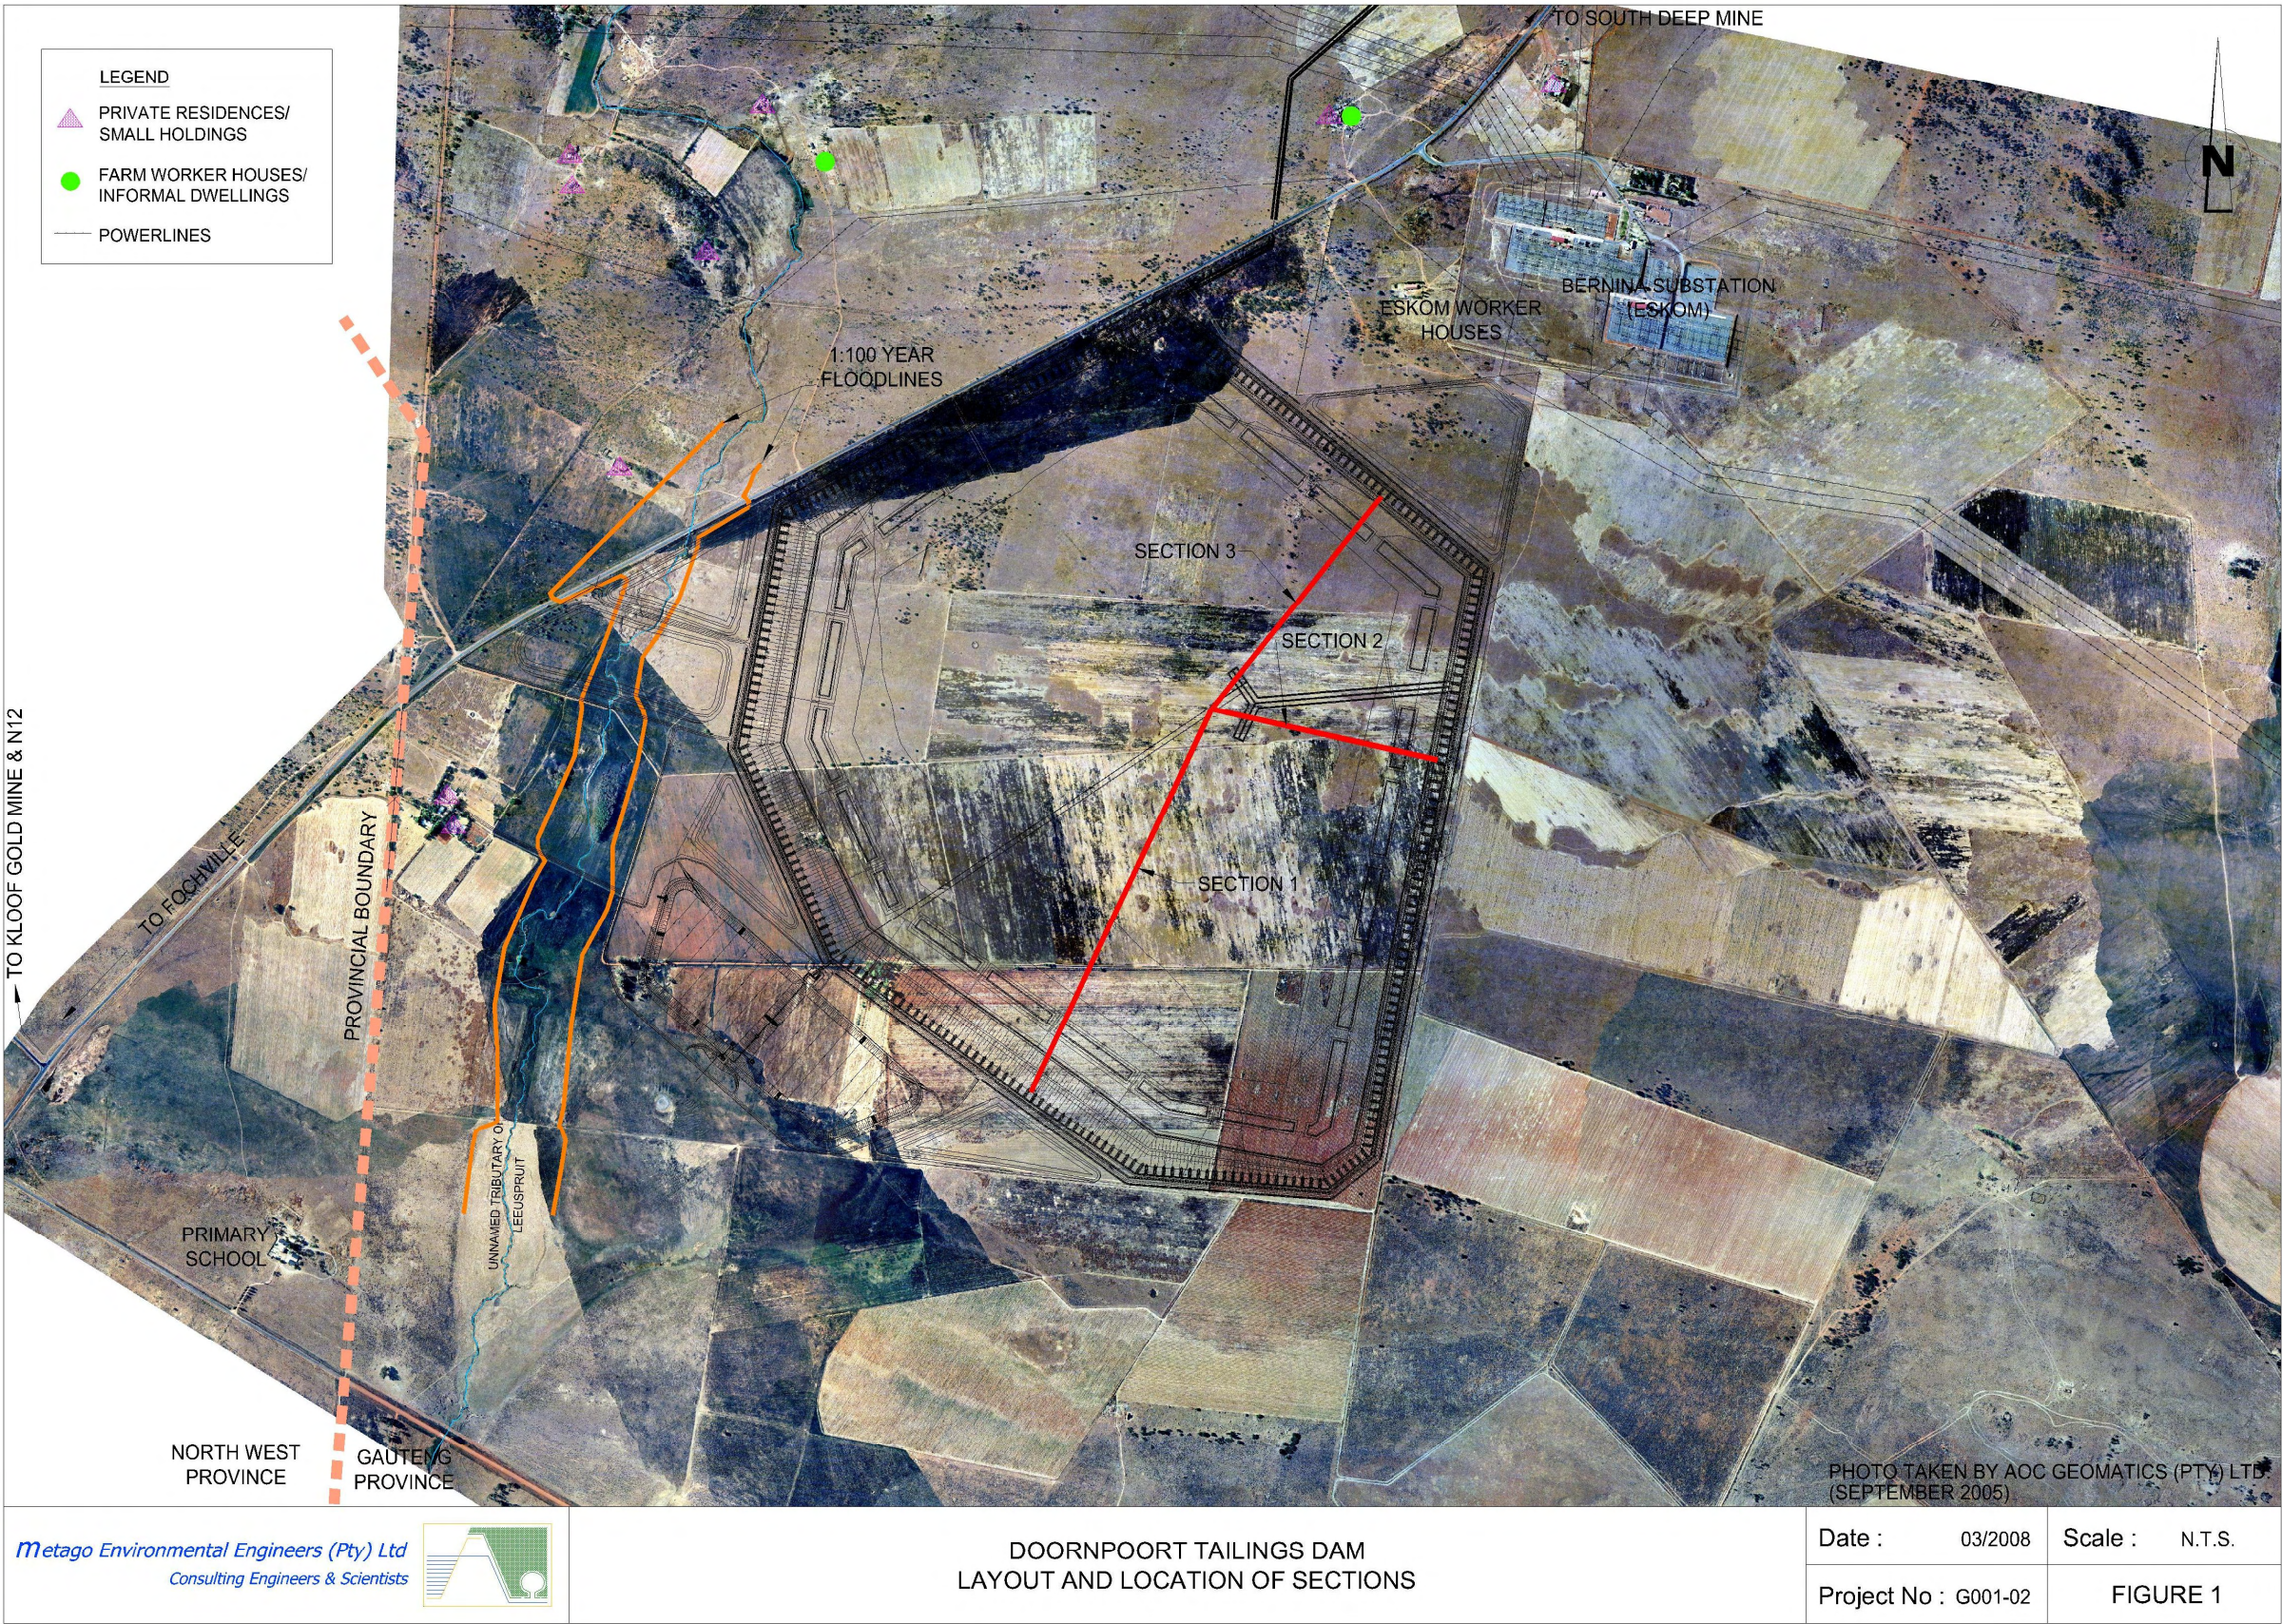
FIGURE 1: LAYOUT AND LOCATION OF SECTIONS FOR SEEPAGE MODELLING

- Estimate the maximum likely seepage flux from the underlying foundation soils;
- Size and position the underdrains as shown on Figure 1;
- Check if the drains will function adequately in terms of controlling the phreatic surface and preventing daylighting of the phreatic surface on the outer slopes of the tailings dam and starter walls. This is important to ensure that hydrostatic pressure build up does not take place below the composite cover.
